REPORT OF THE CIVIL AERONAUTICS BOARD
on the
Investigation of a Mid-Air Collision Between Two Aircraft
Engaged in Local Instruction Flights

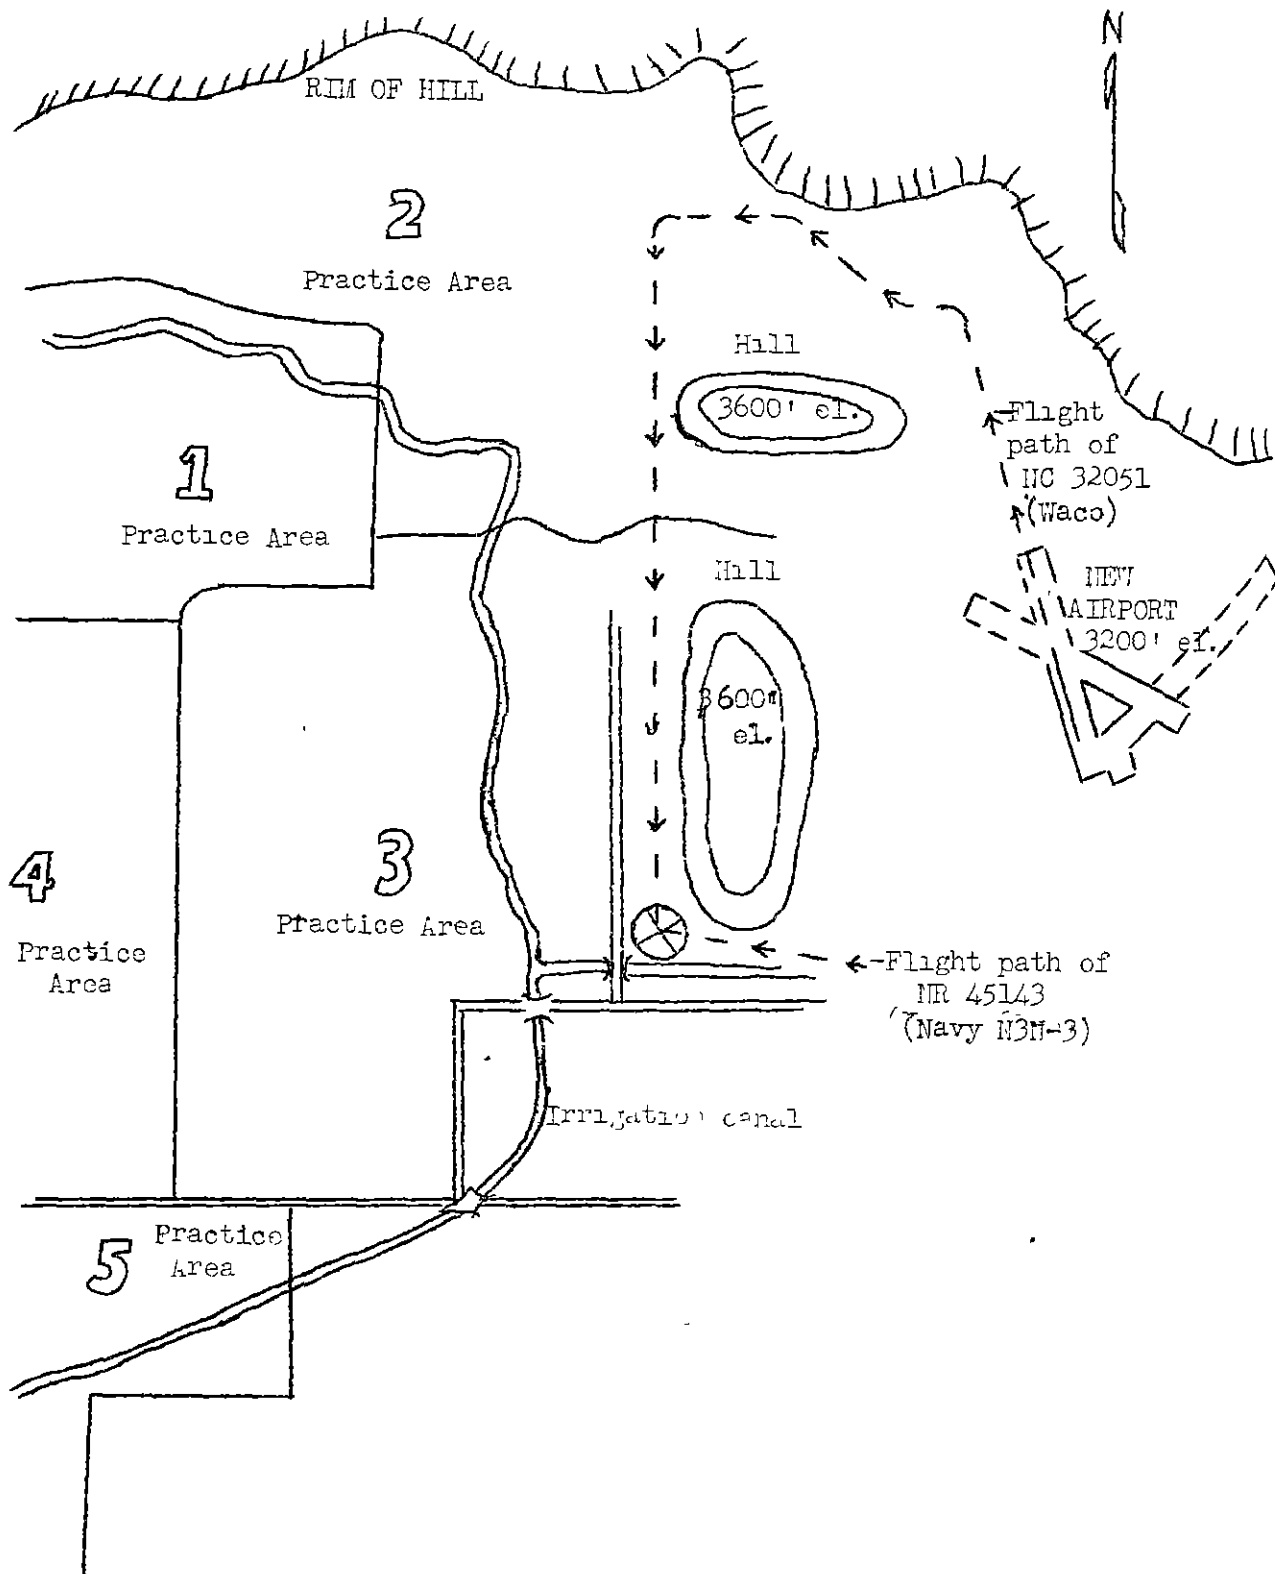
Instructor Morrow and Student Donohue took off from Prineville Airport about 8:44 a.m. for their assigned practice area, No. 3, southwest of the airport where they were to practice a series of low sequence maneuvers at an altitude of around 500 feet. Approximately eleven minutes later Student Furse took off from the same airport with instructions to proceed to practice area No. 5 and practice a sequence of high altitude maneuvers at and above 1500 feet. While Furse was flying south through area No. 3 to reach his assigned area, the Navy N3N, which was headed approximately west-northwest, collided with the Waco at an altitude of about 500 feet. (See sketch Page 2.) Both planes fell to the ground, out of control, 1250 feet apart.

Examination of the wreckage revealed no evidence of failure of any part of either aircraft prior to the collision. Marks on both planes indicated that the left wing "N" strut of the Navy N3N had struck and severed the upper left wing tip of the Waco, while its propeller tore off the Waco's left stabilizer and elevator.

In all probability, the Navy N3N would have been difficult for Furse to see while he was heading south, as it was east of his plane and in a brilliant early morning sun. It appears likely also that the occupants of the Navy N3N were preoccupied with checking reference points on the ground and failed to see the Waco.
